Galvanized Steel Reinforcement in Concrete: An Overview

**Professor Stephen R Yeomans
University of New South Wales
Canberra, Australia**

Editorial Note

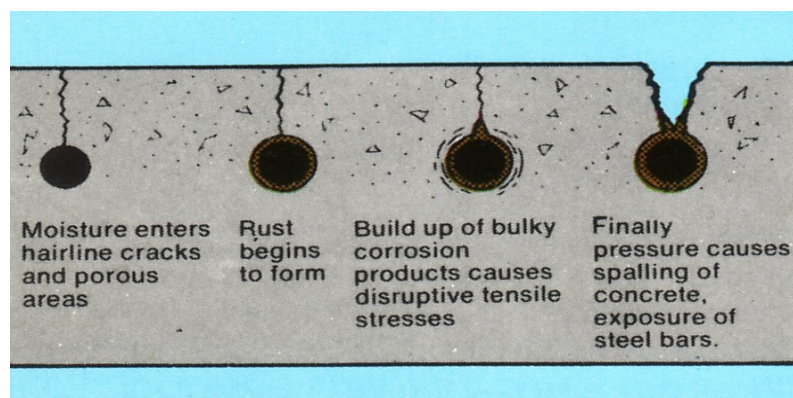
Figure 1. The progress of corrosion-induced damage in concrete.

Should corrosion of the reinforcement occur significant damage to the concrete mass soon follows, as shown schematically in Figure 1. The corrosion products formed are expansive (2-10 times larger) and precipitate at the bar-concrete interface. This causes a swelling pressure of sufficient magnitude (3-4 MPa) to crack the concrete in tension, the cracks usually running from the bar to the nearest outer surface. Once cracking has occurred, rust staining of the surface usually follows with subsequent delamination of the mass or spalling of pieces of concrete from the surface. By this stage, the structure would be seriously distressed, and repair would be necessary to extend its life.

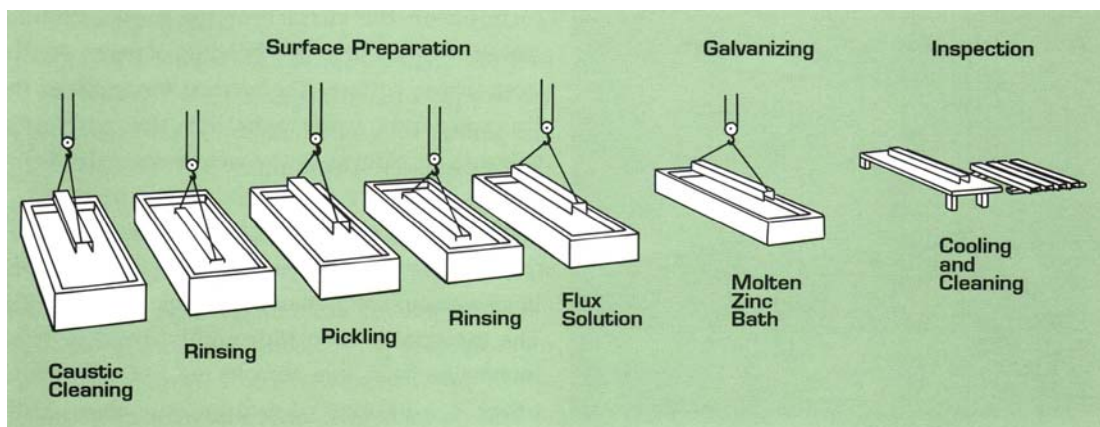
Figure 2. Schematic of hot-dip galvanizing process.

Zinc can be applied to the surface of steel in a variety of ways but for structural steelwork (generally >5 mm thick) hot dipping is the preferred and most widely used method. This involves immersing cleaned steel in a bath of molten zinc at about 470°C during which a metallurgical reaction occurs between the steel and the zinc. The layout of a typical hot dip galvanizing facility is shown in Figure 2.

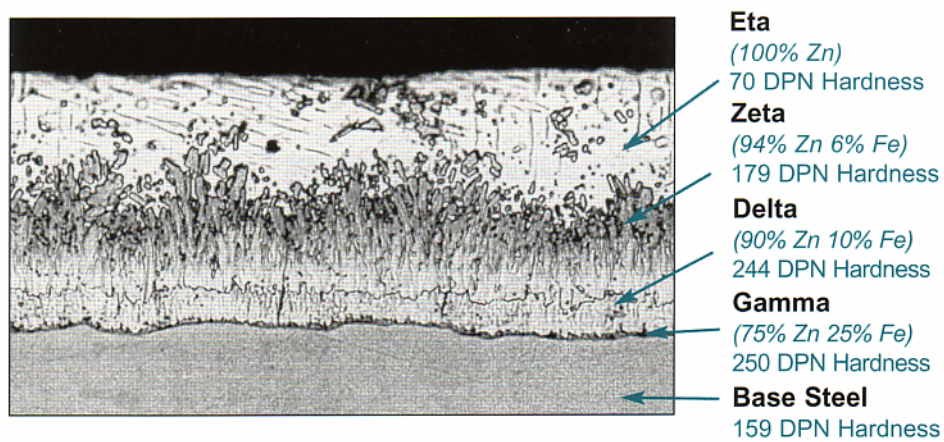
Figure 3. Photomicrograph of hot-dip galvanized coating showing detail of the alloy layers and their hardness

The reaction between steel and molten zinc produces a coating on the steel made up of a series of iron-zinc alloy layers (gamma, delta and zeta) which grow from the steel/zinc interface with a layer of essentially pure zinc (eta) at the outer surface. What distinguishes galvanizing from other types of coatings is that the coating is metallurgically bonded to the steel; it actually becomes an integral part of the steel, in stark contrast to the situation with paints and epoxy coatings which simply attach to the steel surface by physical bonding. The alloy layers in the coating are harder than the base steel resulting in a coating that is not only firmly adhered to the steel but is tough and hard and can resist abrasion and fairly heavy handling. It also allows the galvanized article to be handled, transported and fabricated in much the same way as ordinary steel. A typical (so-called bright) galvanized coating structure is shown in Figure 3.

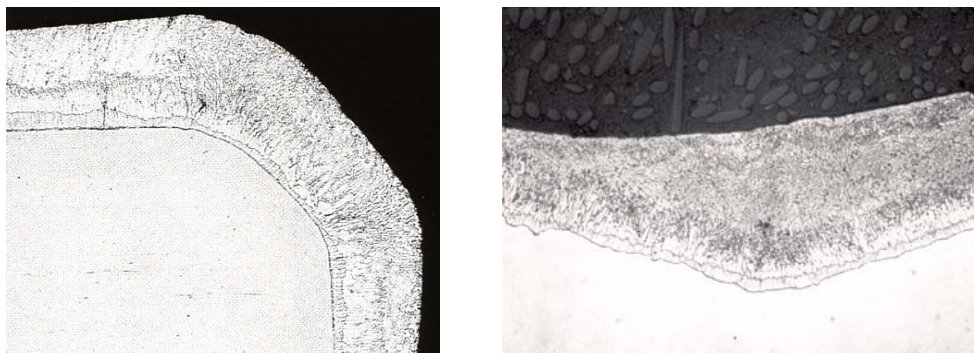
Figure 4. Corner protection and extra coating thickness at recesses in hot-dip galvanized coatings.

A unique feature of galvanizing, since it is a total immersion process, is that all areas of the product are coated including those that are hidden or hard to reach such as recesses and internal surfaces. Galvanizing also naturally produces coatings that are at least as thick at corners and edges, and sometimes thicker, as on other parts of the product, as shown in Figure 4.

Due to the vectorial nature of the growth of the alloys, the coating does not thin out on edges and corners as do paint or spray applied coatings. Since coating damage is most likely to occur at these regions during handling, transportation and fabrication, the extra thickness affords additional protection where it is most needed.

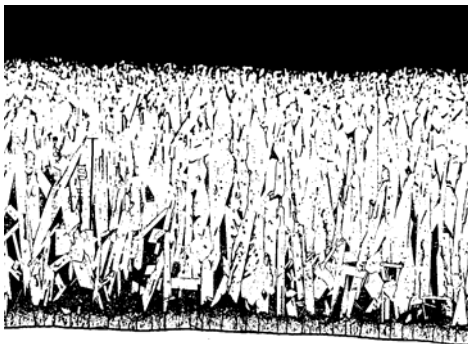
Figure 5. Galvanized coating on silicon-containing (reactive) steel.

Galvanized coatings do not necessarily contain all of the alloy layers shown above. Depending on the steel chemistry and the processing conditions, the coating may contain only one or two of the layers. For example, the microstructure of the coating on silicon-containing steel shown in Figure 5 consists almost entirely of enlarged zeta crystals, due to the reactive nature of the steel. Also, the zeta crystals have grown to the surface of the coating and have consumed the outer pure zinc layer. This coating would have a dull gray surface appearance. The effect of the silicon content of the steel on the thickness of the galvanized coating, known as the Sandelin Effect, is shown in Figure 6.

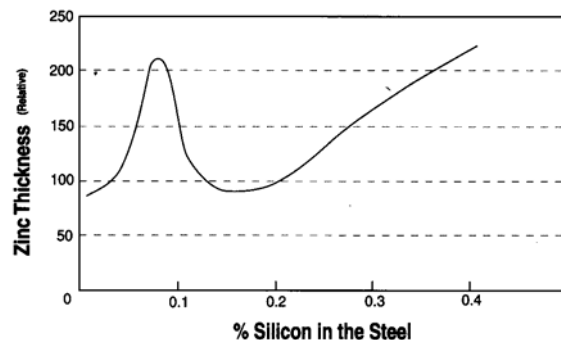
Figure 6. Effect of silicon content of steel on zinc coating thickness.

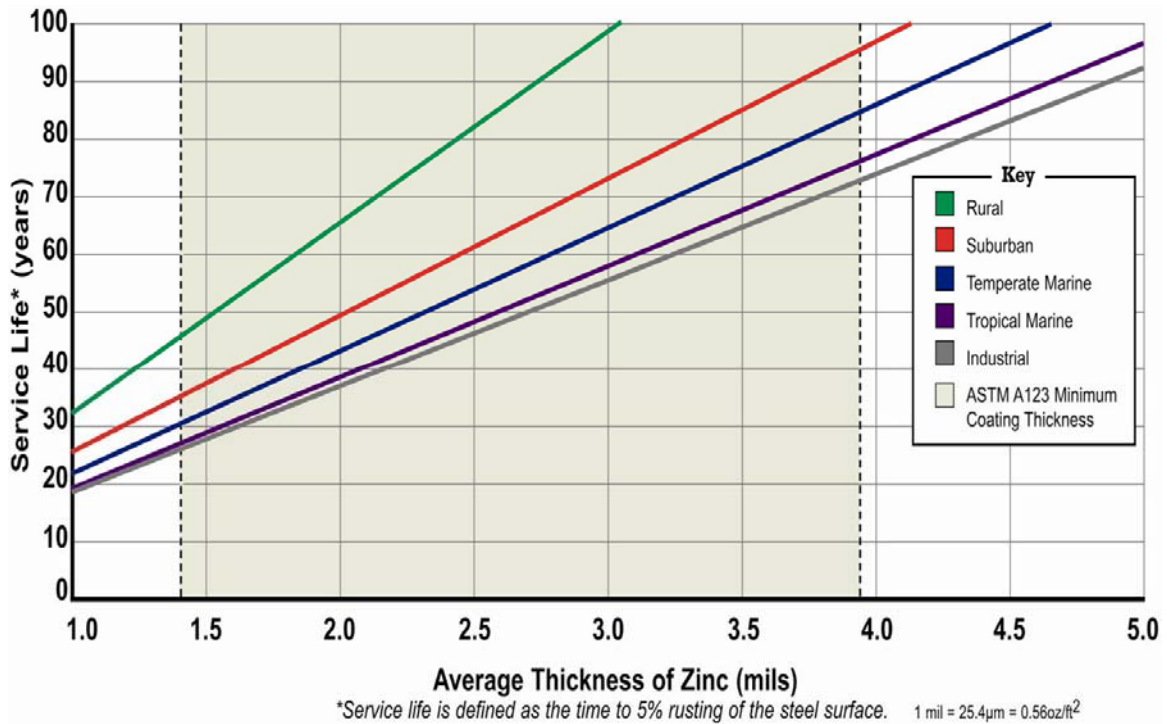
Figure 7. Service life chart for hot-dip galvanized coatings.

The anticipated service life of zinc coatings of varying thickness in a variety of atmospheric exposure conditions is shown in Figure 7. It is to be noted that this data, relating to conditions where the surface is fully exposed, shows that the corrosion rate of zinc tends to be quite linear over time. This is due to the fact that corrosion of the coating in the atmosphere is usually generalized and the coating can be refreshed by water action to remove the corrosion products. It is not expected that galvanized steel in concrete will behave in the same way since corrosion in the somewhat 'fixed' environment of concrete is more localized and the corrosion products so formed are restricted in their movement away from the surface, so tending to stifle the process.

The service life reported in Figure 7 also relates to the time to 5% rusting over the entire surface, not the time for complete removal of the whole coating mass. Note that 1 mil = 25.4 microns coating thickness equivalent to a coating mass of 0.58 oz/ft² or approximately 182 g/m².

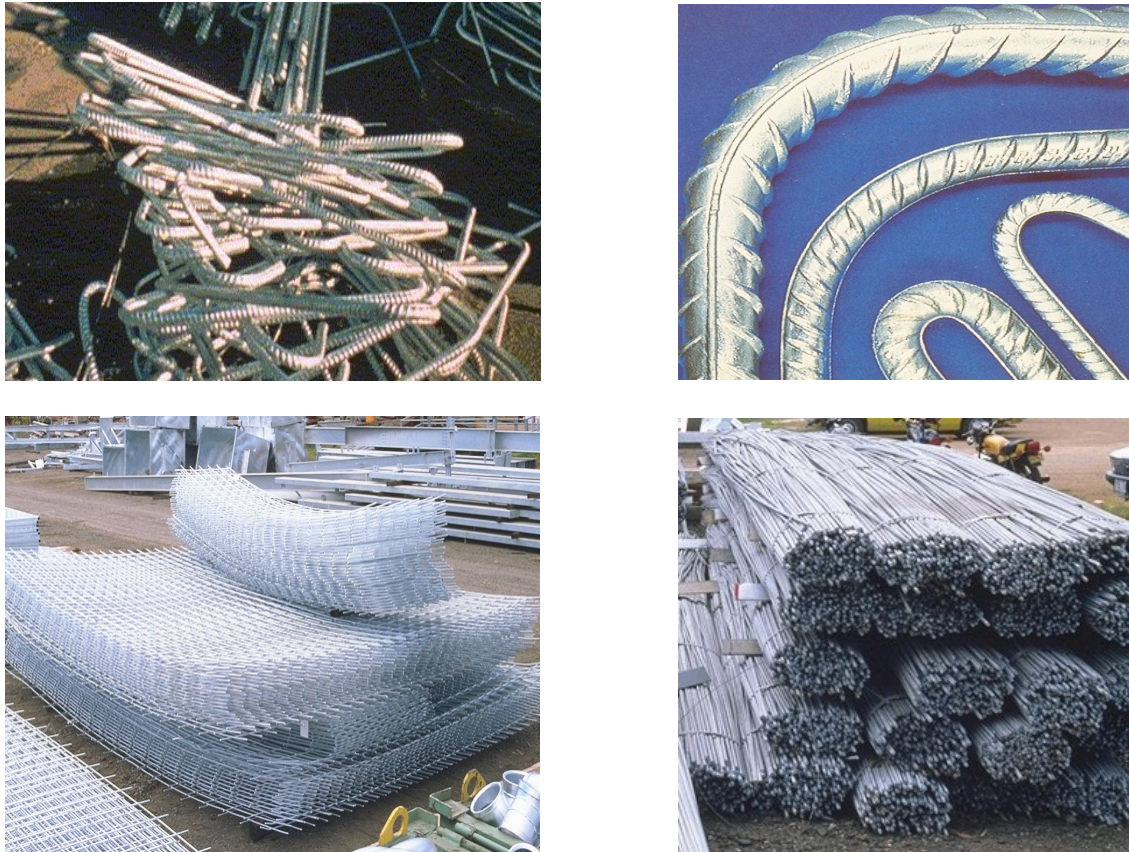
Figure 8. A variety of galvanized steel products for use in concrete.

As an alternative to fabricating straight bars after galvanizing, prefabricated bars bent to special configurations or complete cage sections (e.g., spiral column reinforcement or formed mesh) can be galvanized. This offers the distinct advantage that little or no damage to the coating will occur as may be the case with normal fabrication practices. Examples of a variety of steel products commonly used in reinforced concrete construction are shown in Figure 8.

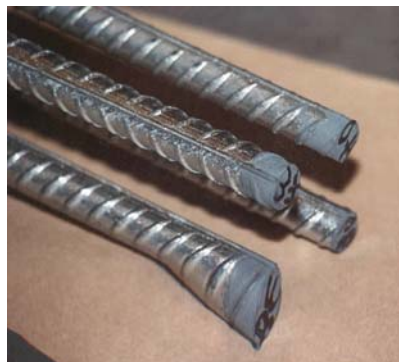
Figure 9. Showing touch-up repair of the cut ends of galvanized rebar using an inorganic zinc-rich paint.

The use of a zinc-rich paint (either organic or inorganic) is the most rapid and convenient means of repair (see Figure 9). Zinc dust paints contain between 65-69% zinc by weight or greater than 92% metallic zinc in the dry film. Inorganic paints are particularly useful for repair and touch-up that may spread over undamaged galvanized areas. The paint is applied by brush or spray over a surface that has been prepared to a near-white finish. Thorough surface preparation is important for good adhesion. A total film thickness of 100 µm is usually specified for optimum performance and thickness measurements are taken to ensure that the required coating is applied.

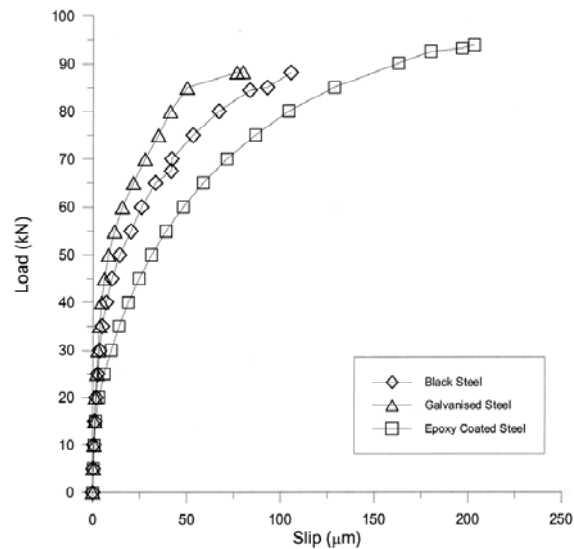
Figure 10. Load-slip data for black, galvanized and epoxy coated ribbed bars.

- in beam tests, at ultimate load there was no significant difference in the free-end slip of galvanized bars and black bars. At intermediate loads there was a noticeable reduction in slip for galvanized bars compared to black steel bars as shown in Figure 10.

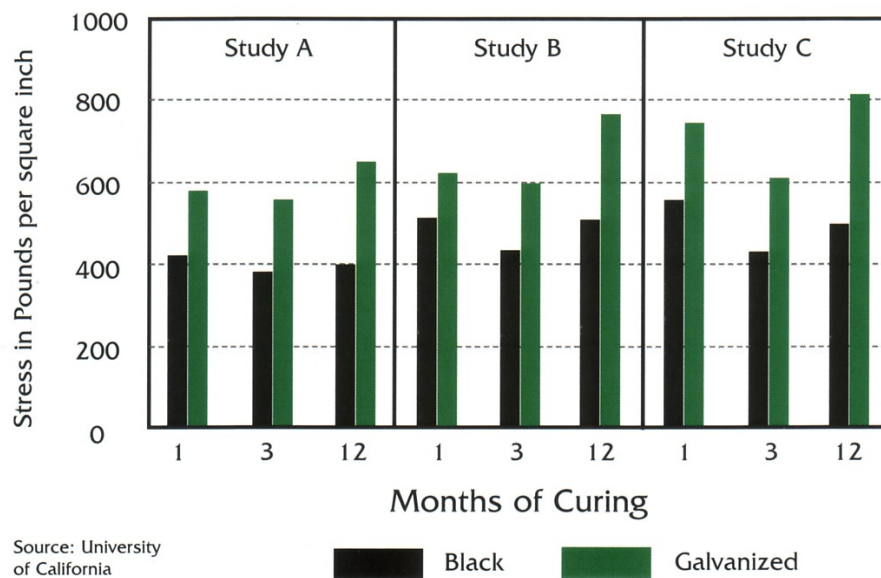
Figure 11. Comparing the bond strength of black and galvanized bars.

What is clear is that the bond of galvanized bar is no less than that of equivalent black steel bar; in fact it may be higher than that of black steel. Multiple comparative studies undertaken at the University of California (Figure 11) clearly shows this effect. Despite the clarity of these results there are however a number of questions that do arise when galvanized reinforcement is to be used. These principally relate to the effect that hydrogen evolution, as a result of the reaction between zinc and wet cement, may have on the bond capacity, and the use of chromates to overcome this perceived problem.

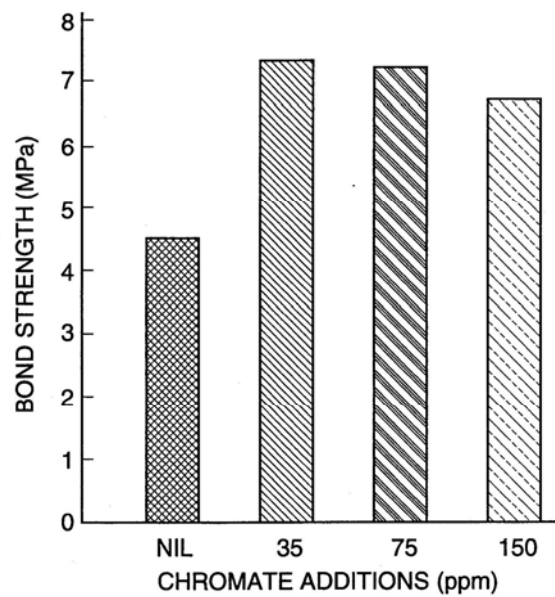
Figure 12. The effect of chromate additions to concrete mix water on the bond strength of galvanized bars.

In other work comparing black, galvanized and epoxy coated plain bars, there was no statistically significant difference in the ultimate bond stress of plain black steel bars and galvanized bars while the epoxy coated bars were some 26% less. Further, the addition of chromates in the mixing water (35-150 ppm by weight of cement) significantly increased the bond strength of galvanized bars with the largest increase (about 38%) for additions of 35 ppm (see Figure 12). In related work comparing plain black bars and galvanized bars either untreated or treated with solutions of sodium dichromate, the galvanized bars were 50% superior in bond strength than plain black bars, and the sodium dichromate treatment to the bar prior to casting did not result in any significant difference when compared with untreated galvanized bars.

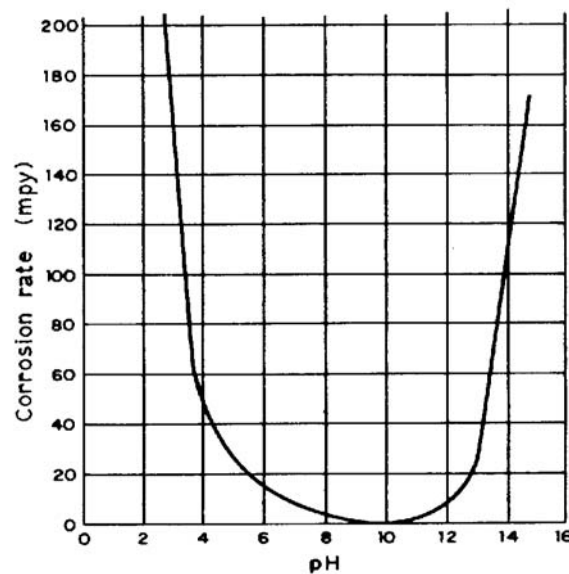
Figure 13. The corrosion rate of zinc as a function of the pH of the environment

Under the highly alkaline conditions of concrete a microscopic oxide layer is formed on the steel surface of the reinforcement, the so-called passive film. This passive film impedes the dissolution of the iron and so the corrosion of steel reinforcement is severely limited, even in the presence of moisture and humidity. In the case of zinc, the situation is different to steel since zinc is an amphoteric metal. This means that the zinc is stable over a wide range of pH, from approximately 6 to 12.5, but below and above these values the corrosion rate increases exponentially as shown in Figure 13.

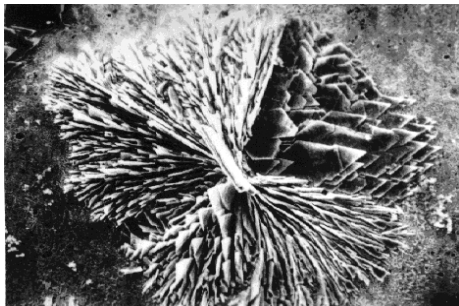
Figure 14. CaHZn crystals after 24 h in Ca(OH)_2 solution of pH 12.6.

Regarding the morphology of the passivating layer, analysis of the corrosion products of galvanized steel in calcium-rich alkaline solutions shows that when the pH is around 12.6, the surface is totally covered after two or three days mainly by CaHZn crystals as shown in Figure 14. Its appearance is that of a very compact carpet of crystals. As the pH increases so does the CaHZn crystal size to the point that the crystals cannot completely cover the surface and, under these conditions, complete passivation of the surface is not possible and dissolution continues at a high corrosion rate.

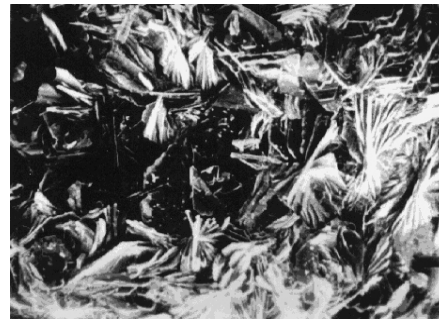
Figure 15. CaHZn crystals after 10 days in $\text{Ca(OH)}_2 + \text{KOH}$ solution of pH 13.24.

At even higher pH values (above 13.5), the crystals of CaHZn become quite coarse and they grow as isolated crystals (Figure 15). The reason for this is that at pH values above 13.2, the concentration of Ca^{2+} ions in solution is depleted. At these high pH values, because the formation of the passive layer of CaHZn crystals is impeded, the dissolution of the zinc is not retarded and as a result the galvanized coating may completely dissolve in a short period of time.

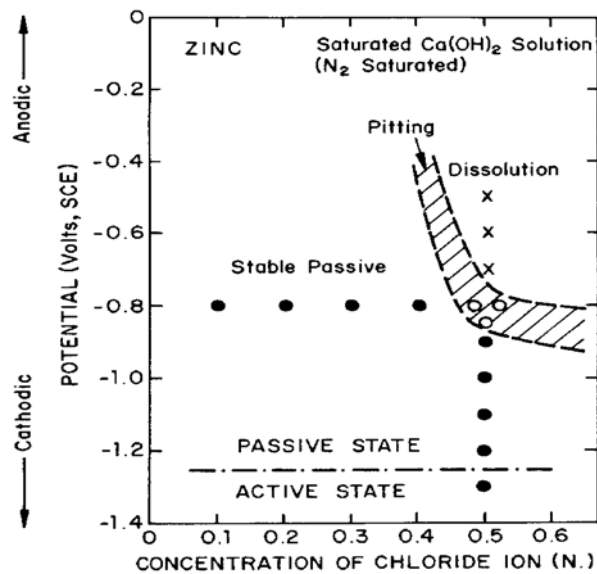
Figure 16. Corrosion of zinc in the presence of chlorides.

These values do vary in the actual environment of concrete. What has been observed in a range of research and the results from field studies, is that the chloride threshold for galvanized bars is at least 2-2.5 times higher than that for black steel, to as much as 8-10 times higher.

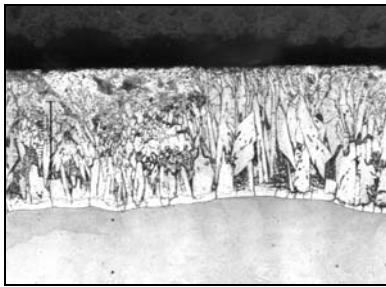
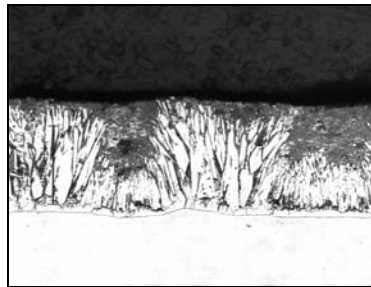
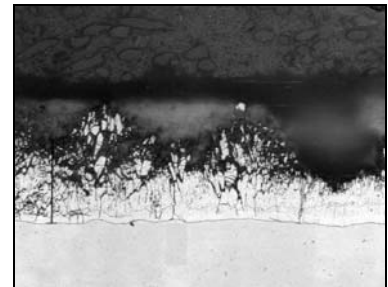
a) Freshly galvanized steel with 180 μm thick alloy layer coating.

b) Galvanized bar exposed to fresh concrete showing partial loss of outer pure zinc layer. Remaining coating ~ 164 μm thick.

c) Exposure to chloride-contaminated concrete showing loss of pure zinc layer with intrusions around alloy layers. Average coating thickness ~ 110 μm .

Figure 17. Changes in the galvanized coating with exposure to concrete. (200x)

This research has indicated that when the galvanized coating first comes in contact with wet cement and is initially passivated, about 10 μm of zinc is dissolved from the pure zinc (η) layer of the coating. This effect is shown in Figure 17 for a galvanized steel with an initial coating thickness of 180 μm (Figure 17a) embedded in non-chloride contaminated concrete for a short period (Figure 17b). The average thickness of the coating remaining at this stage is 164 μm and the coating retains a smooth and bright surface. Studies of galvanized bars recovered from field structures indicate that the coating remains in this condition for extended periods of time provided the conditions in the concrete do not significantly change. In such circumstances, very little further metal loss will occur until the zinc is depassivated and active corrosion commences.

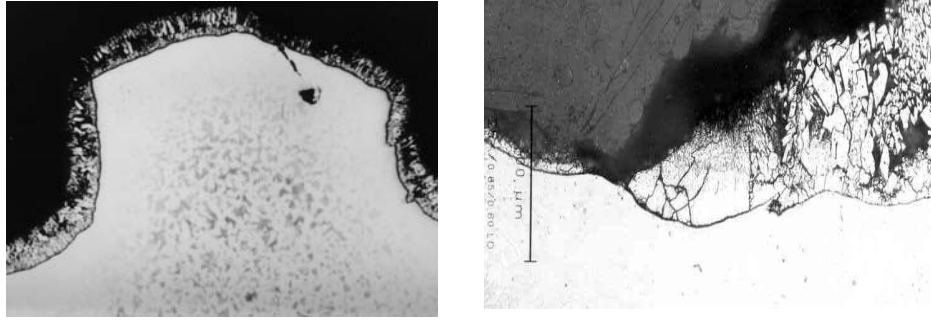
Figure 18. Showing areas of exposed steel on embedded galvanized bar that have been cathodically protected by the adjacent zinc coating.

Though the coating appears to be disintegrating at this stage, a dense layer of both the γ and δ phases remains intact at the bar surface and this affords ongoing corrosion protection to the underlying steel. Once the coating is completely lost from small areas of the bar surface, the zinc continues to provide sacrificial protection over distances of up to about 8 mm (as revealed in one experiment). Some examples of this effect are shown in Figure 18.

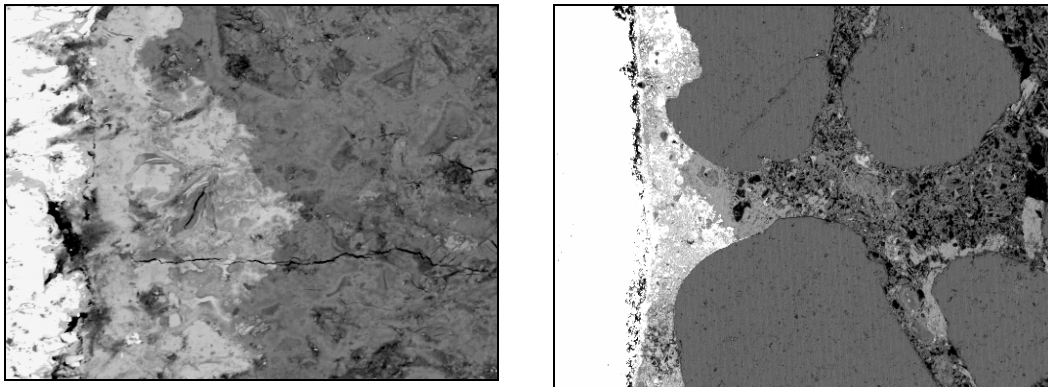
a) Showing partial dissolution of the galvanized coating (left) and plume of zinc-rich corrosion product (centre) migrating into cement matrix (1000x).

b) Migration of zinc-rich corrosion products away from the bar/matrix interface into the cement matrix. Large particles are sand. (100x)

Considerable work has also been done to identify the nature of the corrosion products produced and the effect of these on the concrete mass. A number of minerals have been identified in the corrosion products, primarily zinc oxide and zinc hydroxide. A unique feature of these products is that they are friable (loose and powdery) minerals, are less voluminous than iron-rich corrosion products, and are able to migrate away from the bar and into the adjacent concrete matrix where they fill voids and microcracks. This is shown in Figure 19 in which the plume of zinc-rich corrosion products appears white against the gray calcium-rich cement matrix.

In contrast to the situation encountered when steel corrodes in concrete, the presence of the zinc corrosion products cause very little physical disruption to the surrounding matrix, thereby maintaining the integrity of the cover concrete. There is also evidence that the presence of these corrosion products and the filling of the pore space in the matrix may create a barrier in the matrix of reduced permeability which not only increases the adhesion of the matrix to the bar but may also reduce the transport of aggressive species such as chlorides through the matrix to the coating surface.

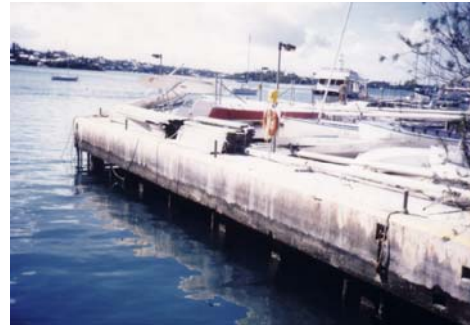
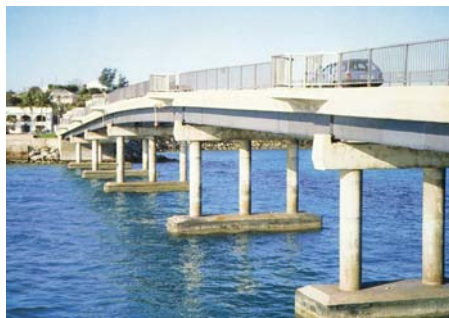
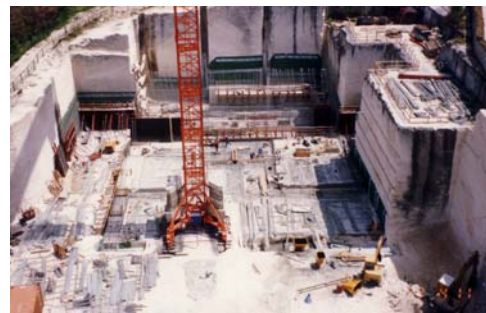
Figure 20. The Bermuda case study.

b) The Royal Bermuda Yacht Club (1968) with galvanized bar, and still in excellent condition.

c) The new Watford Bridge (1979), fully galvanized reinforced.

d) Tynes Bay waste-to-energy plant foundations with 100% galvanized reinforcement.

Follow-up examination confirmed these findings and revealed that the galvanized bars maintained a residual zinc coating thickness at a structure age of 42+ years well in

excess of the minimum requirement. Examination of concrete cores from these structures confirmed the previously mentioned observations that the zinc corrosion products had migrated a considerable distance (300-500 microns) beyond the surface of the coating and into the adjacent concrete matrix with no visible effect on the concrete mass. Field data of this type provides practical evidence of the migration effects of the zinc corrosion products shown laboratory experiments (refer Figure 19).
